TROUT RIVER FLOOD INFORMATION MAP

Canada - Newfoundland Flood Damage Reduction Program

FLOOD INFORMATION MAP TROUT RIVER - NEWFOUNDLAND

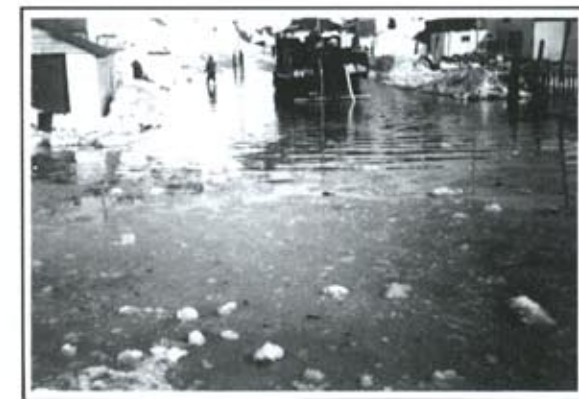
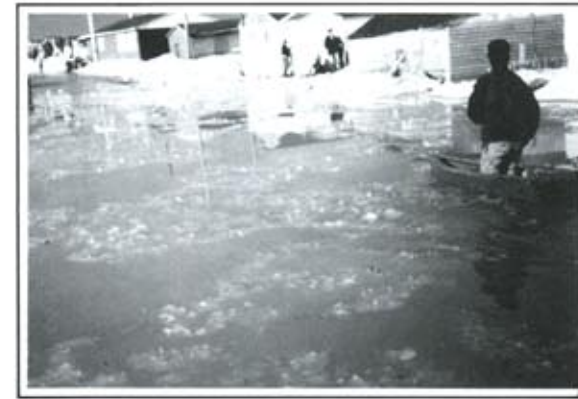
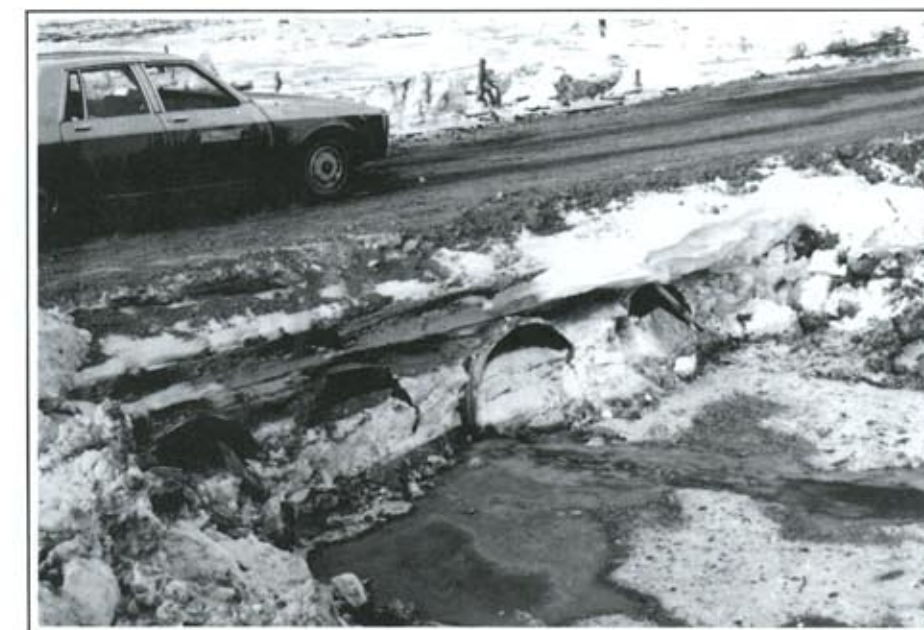
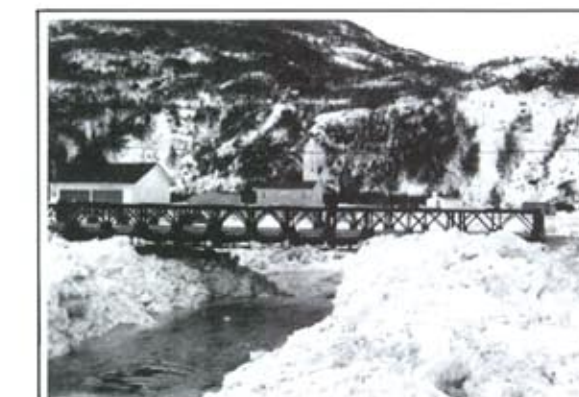
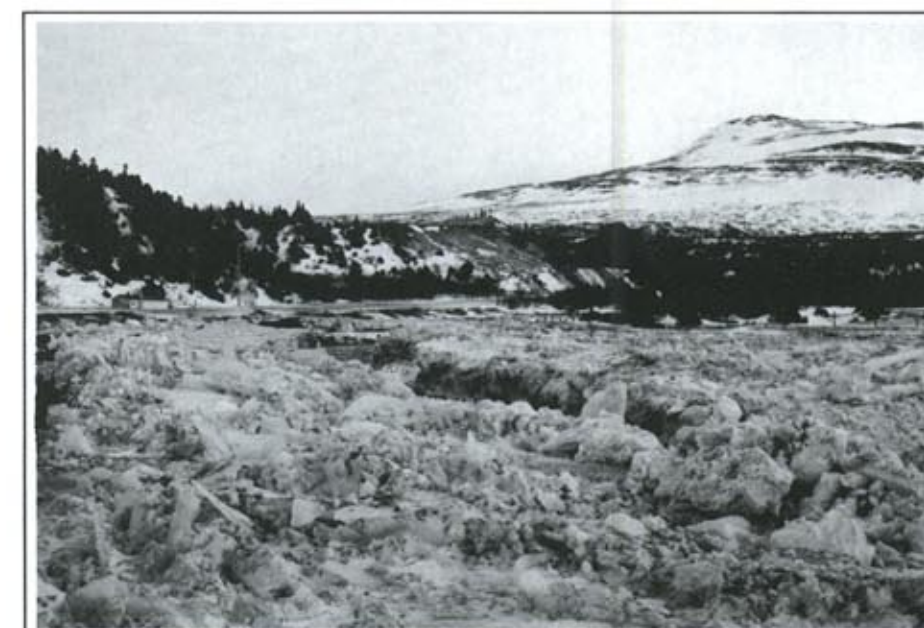
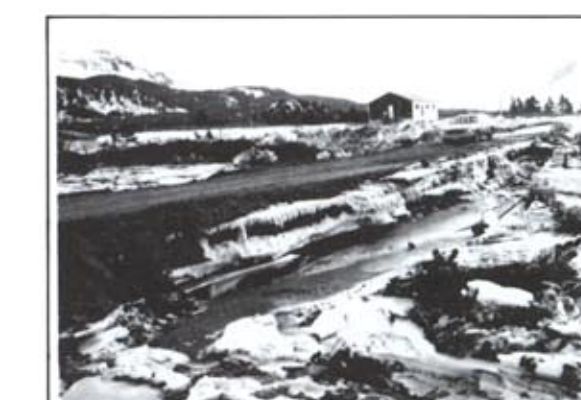
FLOOD ZONES

A "designated floodway" (1:20 flood zone) is the area subject to the most frequent flooding.

A "designated floodway fringe" (1:100 year flood zone) constitutes the remainder of the flood risk area. This area generally receives less damage from flooding.

This is a map of the Trout River flood risk areas - showing the areas prone to flooding - the "designated floodway" in orange and the "designated floodway fringe" in yellow.

Included on this map are flood risk zones along Trout River from the outlet of Lower Trout River Pond to the ocean and in the area of the community known as Emmanuel's Brook.

In recent years the community of Trout River has suffered floods caused by ice jams on both Trout River and Emmanuel's Brook. In January 1990 mild weather and rain caused ice jams to form in Feeder Brook, a tributary of Trout River, and in Emmanuel's Brook. The ice jams at both locations were aggravated by the deep snow drifts which filled in the river channels. The main highway into the community was blocked at Feeder Brook for several hours until the jam was cleared. Near Emmanuel's Brook several houses received considerable damage when the flood waters rose above their main floor level.
